IMAGING FATIGUE CRACKS IN LOW CARBON STEELS WITH THE GEL ELECTRODE

William J. Baxter

Physics Department
General Motors Research Laboratories
Warren, Michigan 48090-9055

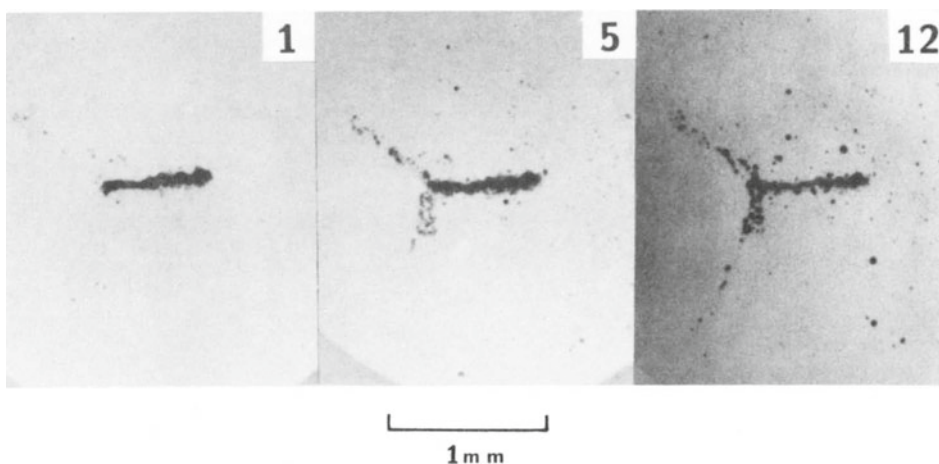
Fig. 1 First, fifth and twelfth in a sequence of gel electrode images of a fatigue crack in a dual phase steel. Each image formed by a 4V, 200 ms pulse.

Enlarged pictures of gel electrode images of a fatigue crack in the dual phase steel are shown in Fig. 1. This particular crack, which is 0.7 mm long, was produced after 1.8×10^5 cycles. The crack was then imaged sequentially with twelve gel electrodes. Only the first, fifth and twelfth images in this series are shown, but they illustrate the repeatability of the crack detection process. The last image is narrower than the first image, but still provides a clear identification of the crack and the characteristic irregularities of the crack path. The last image also contains a background of small spots, particularly along the edge of the notch and close to the fatigue crack. These spots correspond to sites of breakdown of the surface anodic film due to repeated application of the gel electrode, but their distribution suggests that some of these sites may be related to fatigue deformation in the stress field of the notch.

All the images shown in Figs. 1 and 2 were formed with a 4V, 200 ms pulse, which provides good image repeatability but greatly exaggerates the width of the crack. Such images have the advantage of being visible to the unaided eye but suffer from the obscuration of detail, limiting the

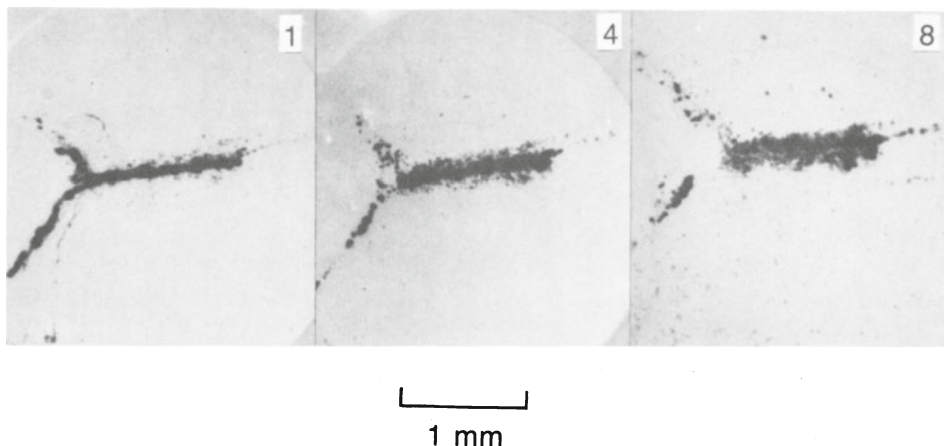
Fig. 2 First, fourth and eighth in a sequence of gel electrode images of a fatigue crack in HSLA steel. Each image formed by a 4V, 200 ms pulse.

A similar sequence of images are shown in Fig. 2 for a fatigue crack formed in a HSLA steel specimen after 4×10^5 cycles. In this example, the width of the image appears to increase gradually throughout the sequence due to the development of a high density of spots along each side of the crack, which again are probably related to the presence of deformation. A total of eight well defined images were obtained in this sequence.

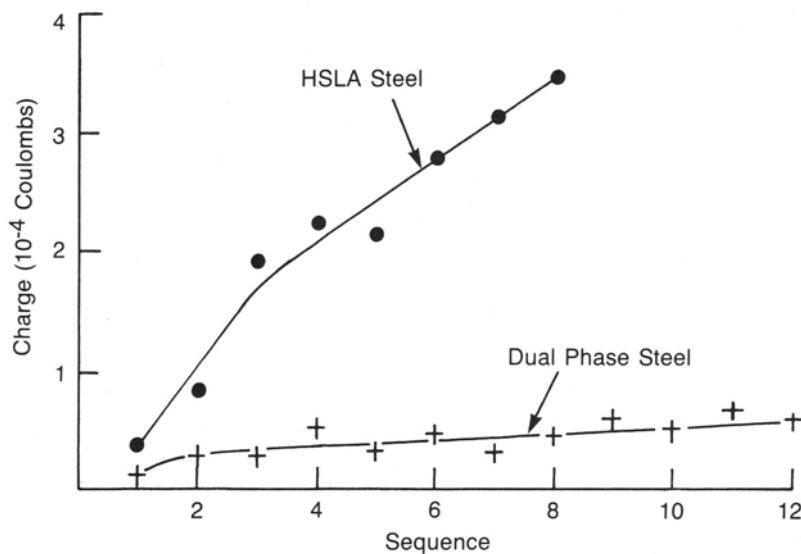
Fig. 3 The charge flow associated with the formation of each image in the sequences illustrated in Figs. 1 and 2. Area of contact of the gel electrode is $\sim 0.1 \text{ cm}^2$.

Subsequent applications of the gel electrode to the crack in HSLA steel produced only weakly developed images surrounded by many very small dots. This fading of the image from HSLA steel was accompanied by a large increase of current from the gel electrode, whereas there was only a modest increase of current during the sequence of reproducible images from the dual phase steel (Fig. 3). Thus this additional current flows, not to the crack which requires only 10^{-5} coulomb/mm of crack length [3] to form an image, but to defects in the anodic film. Under repeated application of the gel electrode, these defects become sufficiently conductive to contribute a random distribution of background spots to the image (Figs. 1 and 2). When the charge to the defects exceeds $\sim 10^{-3}$ coulomb/cm² the crack is effectively short circuited and no longer imaged. From the

results of Figs. 1 to 3, we conclude that a protective anodic film forms on both the ferrite and martensite phases in the dual phase steel, but that the film on the HSLA steel contains defects associated with the fine dispersion of small carbide particles.

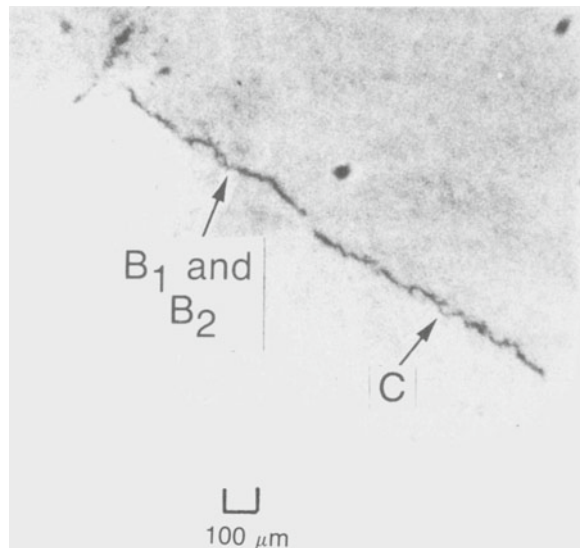
Fig. 4 High resolution gel electrode image of a fatigue crack in HSLA steel. Image formed by a 7V, 10 ms pulse.

spatial resolution to $\sim 50 \mu\text{m}$. To illustrate the microscopic size of the features of a crack which are contributing to the image, it is necessary to form a narrower image by restricting the charge flow. A good example is provided by Fig. 4, which shows an enlarged view of a gel electrode image obtained from a HSLA steel specimen with a 7V, 10 ms pulse. The width of this image is only $\sim 10 \mu\text{m}$, so it can be correlated in a detailed manner with direct observations of the crack itself by scanning electron microscopy. Such a correlation is illustrated by the two scanning electron micrographs in Fig. 5. The two bends in the crack path identified as B_1 and B_2 in Fig. 5(a) correspond to the features similarly labeled in Fig. 4. Similarly, the bend in the main crack and the small branching crack at C in Fig. 5(b) are also resolved in the gel electrode image (Fig. 4). Note that all these geometrical features are formed by crack segments only $\sim 10 \mu\text{m}$ in length.

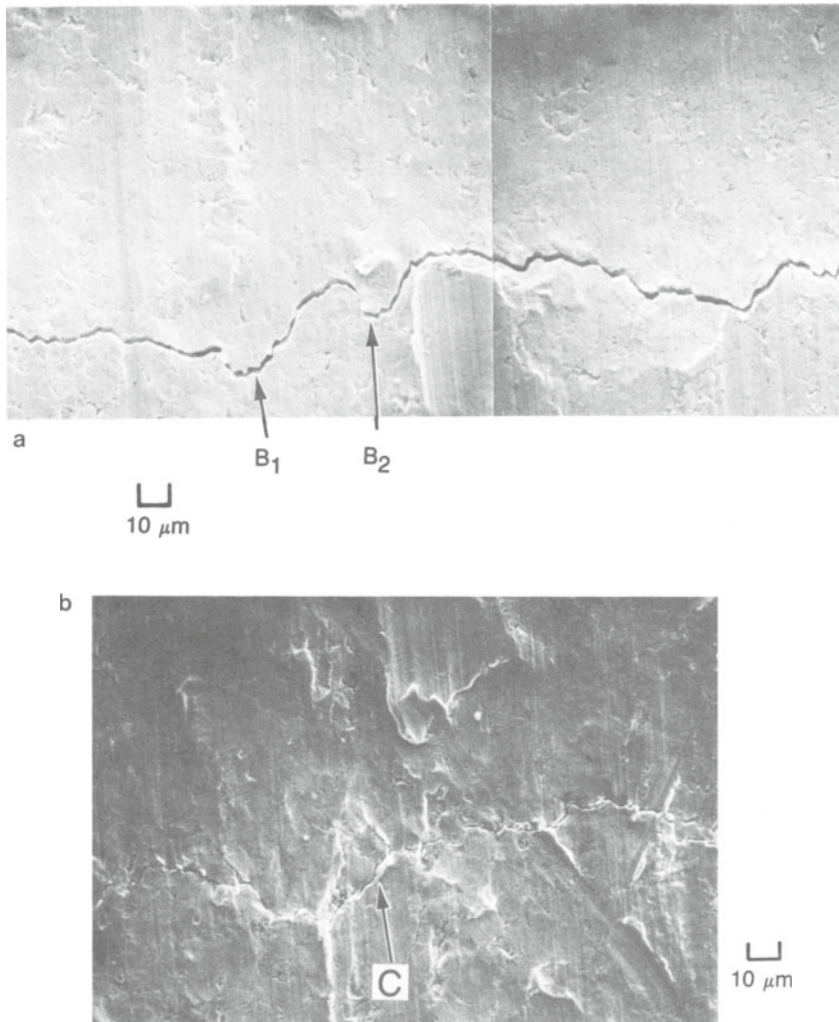
Fig. 5 Scanning electron micrographs of two portions of the crack imaged in Fig. 3. (a) The two bends at location B; (b) The bend and branching crack at location C.
